Olmsted Flowline Replacement (2005)

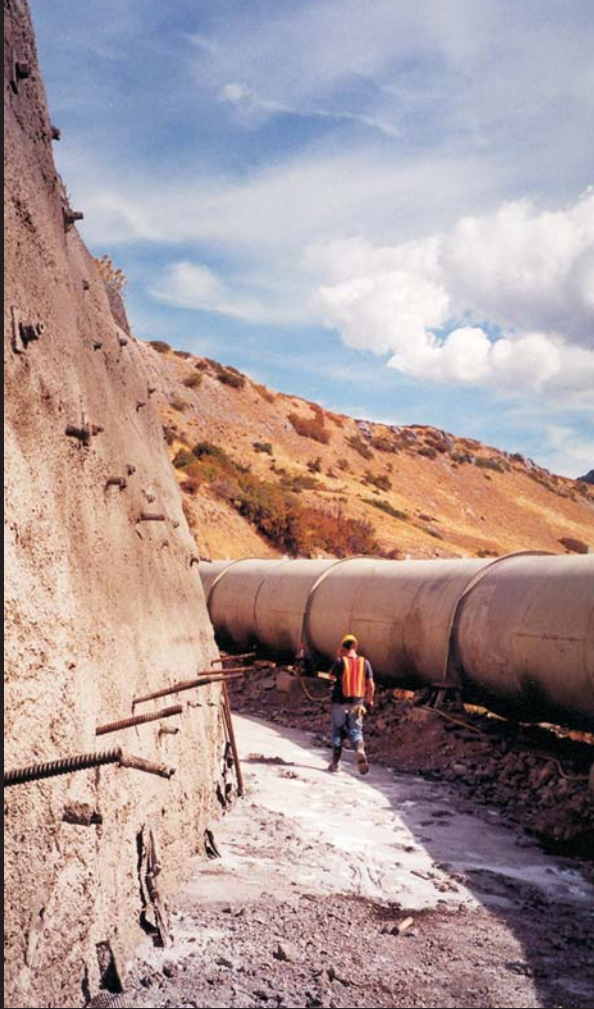
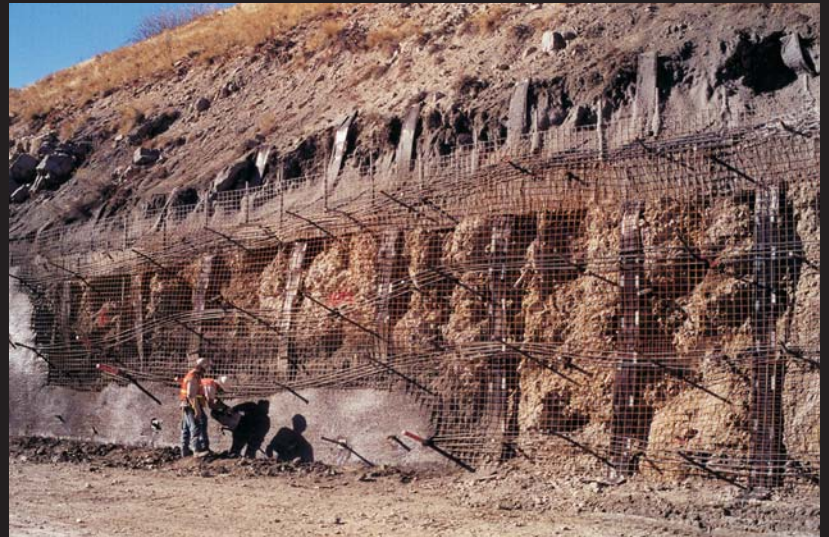
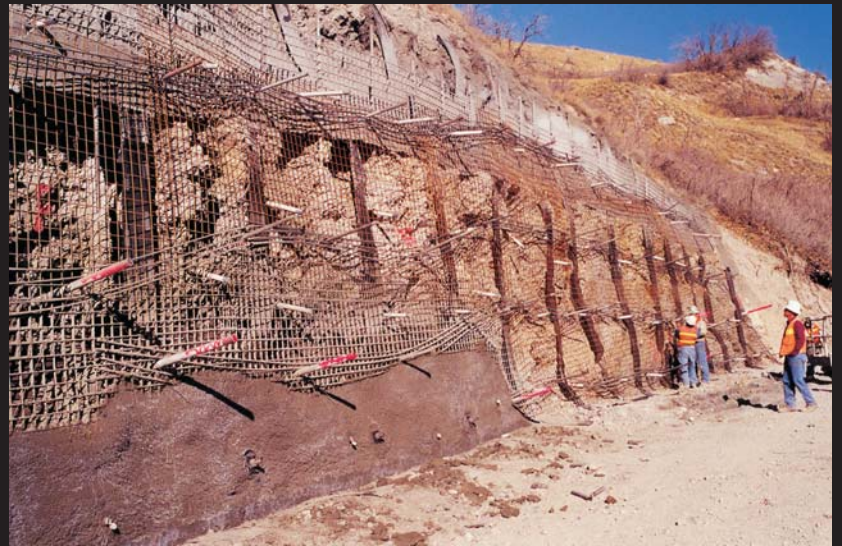
Constructed in Provo Canyon, Utah to facilitate the replacement of a 78-inch pipeline. This construction required the use of soil nail walls with vertical elements to stiffen and support the face during construction. As shown, the vertical elements provided complete support for the face until the final excavation cut was made. Shotcrete was then applied and the wall was completed. These soil nail walls ranged up to twenty-five feet high and support talus slopes extending uphill for several hundred feet at approximately 1.1H:1V.
